# Control of sound insulation in glass facades at Oslo's Opera House

Sigmund Olafsen, Per Kåre Limmestad

Brekke & Strand akustikk as, Oslo, Norway

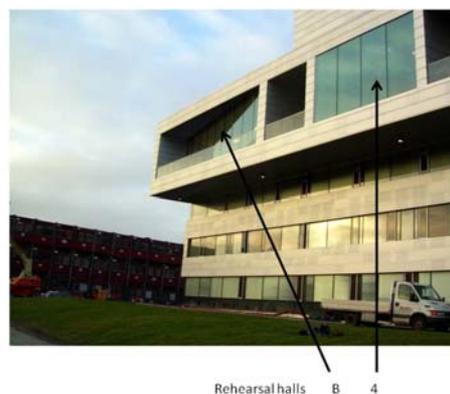
Figure 1, Rehearsal halls B and 4

The east wall of the opera has no external access. This means that the microphone must be mounted either up from the ground or down from the roof of the building. It would not have been practical at the time the measurements were made to use a lift to make the measurements from the ground up. The measurements thus had to be made lowering the microphone from the roof.

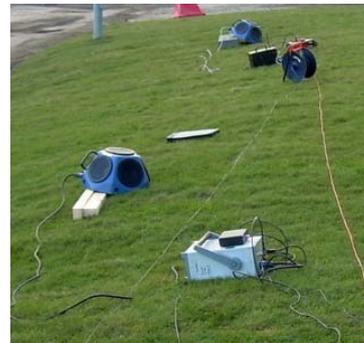
Figure 3, loudspeakers and amplifiers in place

- Two loudspeakers were used simultaneously to give a more uniform and diffuse sound field.
- The facades are at an oblique angle, so the microphone was at somewhat varying distances in front of the facades.

For each of the halls, 5-6 microphone positions were used on the outside of the façade. Both the loudspeakers were Norsonic 250’s. One Norsonic 260 and one Norsonic 280 amplifier were used. For the sound level and reverberation time measurements a Norsonic 118 was used.

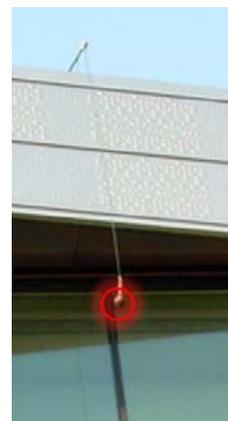
Figure 4, outdoor microphone position

The main purpose of the measurements was to achieve a good estimate of the indoor level. The chosen method of façade sound insulation measurement is based on mounting the microphone 1-2 m in front of the façade. There’s a known theoretical problem with the method in that there may be a comb filter effect. This is due to destructive interference between direct sound from the loudspeaker and reflected sound from the façade to be tested. The ISO 140-5 [2] mentions a problem with measurements of façade insulation with microphones in front of the façade instead of fastened directly onto the façade. However, the standard only says that this might cause unknown systematic errors at low frequencies.

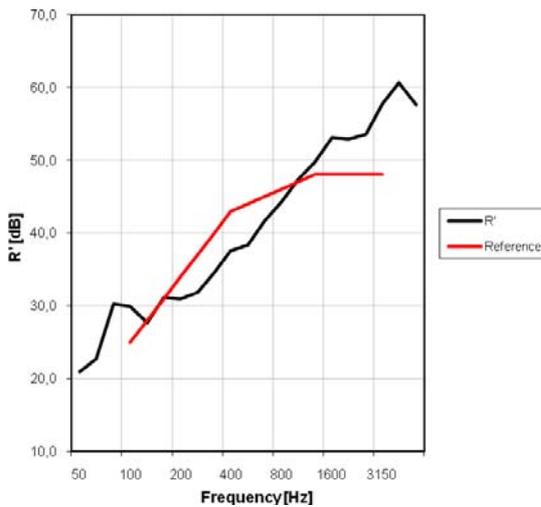
Figure 5, rehearsal hall A

The  $R'$  curves from the three measurements are shown below together with the reference curve. For all the three measurements the frequency range 200 – 800 Hz is critical for the achieved sound insulation. Figure 5 shows rehearsal hall A, figure 6 shows rehearsal hall B and figure 7 shows rehearsal hall 4.

It has been shown [5] that the quality of details can effect the achieved sound insulation of glass facades to a large extent. The measurements from rehearsal halls A and B show no clear dips that indicate leakages, the measurement from rehearsal hall 4 has a dip at 2000 – 2500 Hz which could be due to a small leakage.

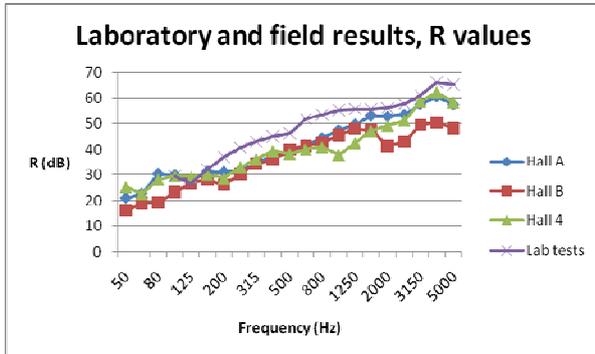
Figure 8, laboratory and field results

The glass formula used in the facades were expected from laboratory measurements and theoretical analysis to give a value of  $R'_{w+Ctr}$  of 41 dB [4]. The results were  $R'_{w+Ctr}$  of 33-37 dB as shown in table 2. Figure 8 below shows our field results compared to the laboratory results.

Laboratory results from Glaverbel have been quoted.

Three different possible explanations of this have been considered:

- Systematic error due to the measurement procedure
- Quality of design and craftsmanship of details
- Double wall resonances between the glasses

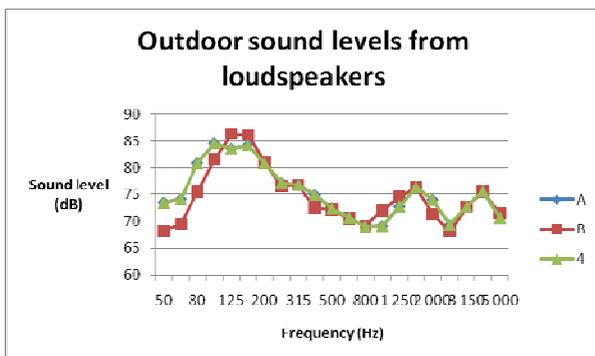
Figure 9, outdoor levels

In figure 9 below the measured values outside the facades are shown.

The spectra look quite what could be expected from the specifications of the loudspeaker and possible ground effects, but there is no indication of a comb filter with repeating dips in the spectrum of the outdoor level. The dip at 2500 Hz has no effect on the resulting sound insulation index, at that frequency range the measured insulation is clearly above the reference curve anyway.
